Ground Liner Underlies Reliant Stadium's Engineering Feat

By Alexandria Hayes

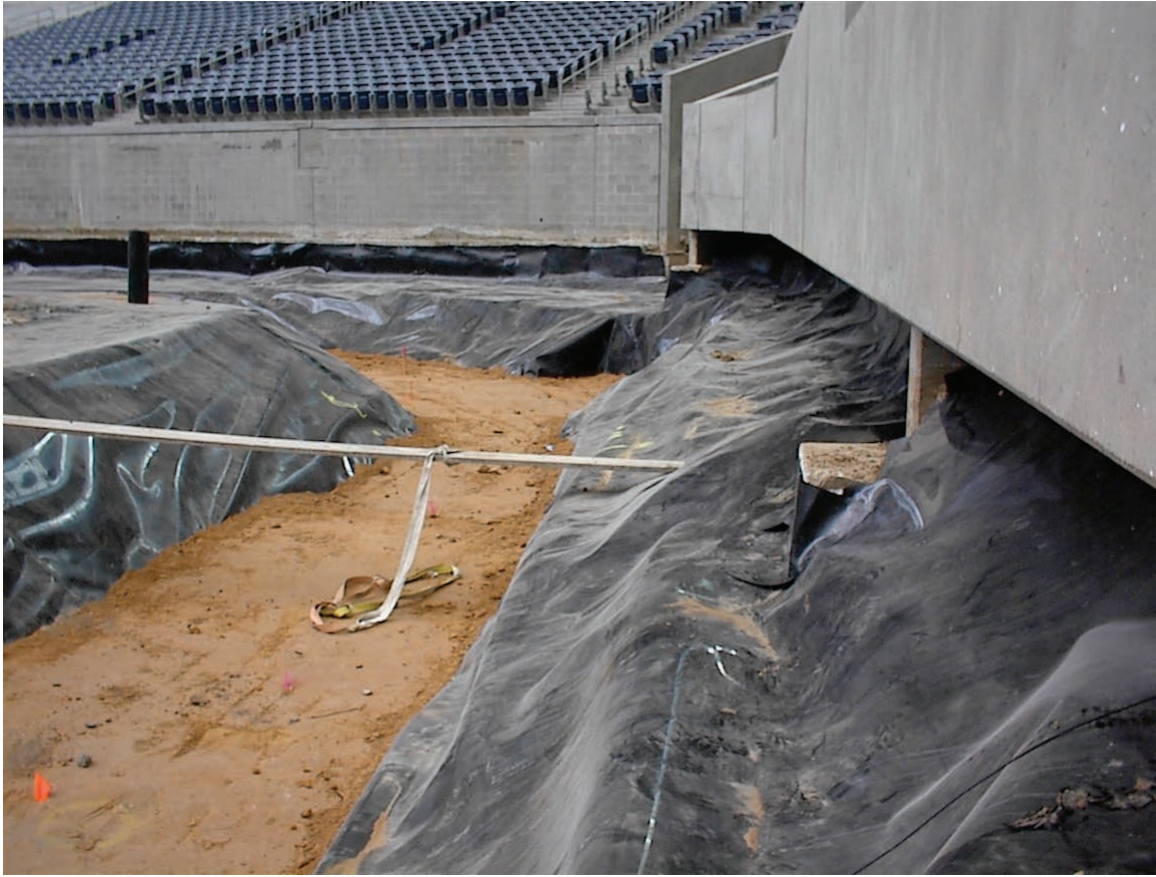
A polyethylene liner protects the sub grade under Reliant Stadium. Where it was possible, high-density polyethylene strips were embedded in structures during their formation and the liner was subsequently welded to them. Where embedding wasn't possible, as in the case of the major foundations, the liner was mechanically attached with a stainless steel batten system. Here, the liner is installed under the bleachers.

Aside from the schedule, the primary challenge for the installers was how to attach the liner – which lies beneath the entire field and under the first 20 feet of the bleachers – to the stadium substructures. Where it was possible, high-density polyethylene strips were embedded in structures during their formation and the liner was subsequently welded to them. Where embedding wasn't possible, as in the case of the major foundations, the liner was mechanically attached with a stainless steel batten system.

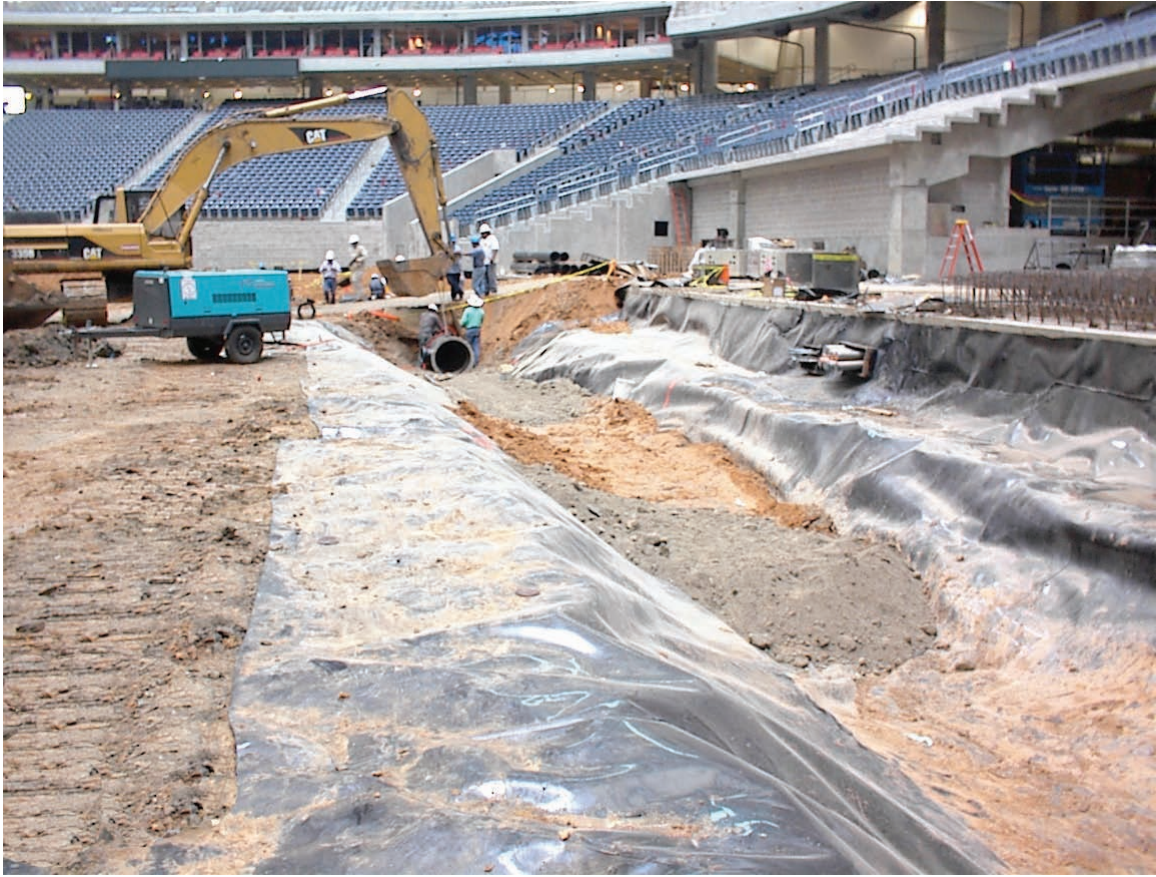
Areas under 30-inch drainage pipes were lined next. The liner was welded to sections that had already been laid. Then welds were nondestructively tested.

Six field employees and two project managers worked for eight months among a dozen other trades to install 115,000 square feet of liner. With only 20% of the area available at a time and a constantly changing scope of work, the team engineered the installation “on the fly.” As areas became available for lining (first the periphery, then the under the drainage system, then the flat areas of the field), they mapped out a plan to lay down the liner and attach it to the substructures and other sections of liner that had already been installed.

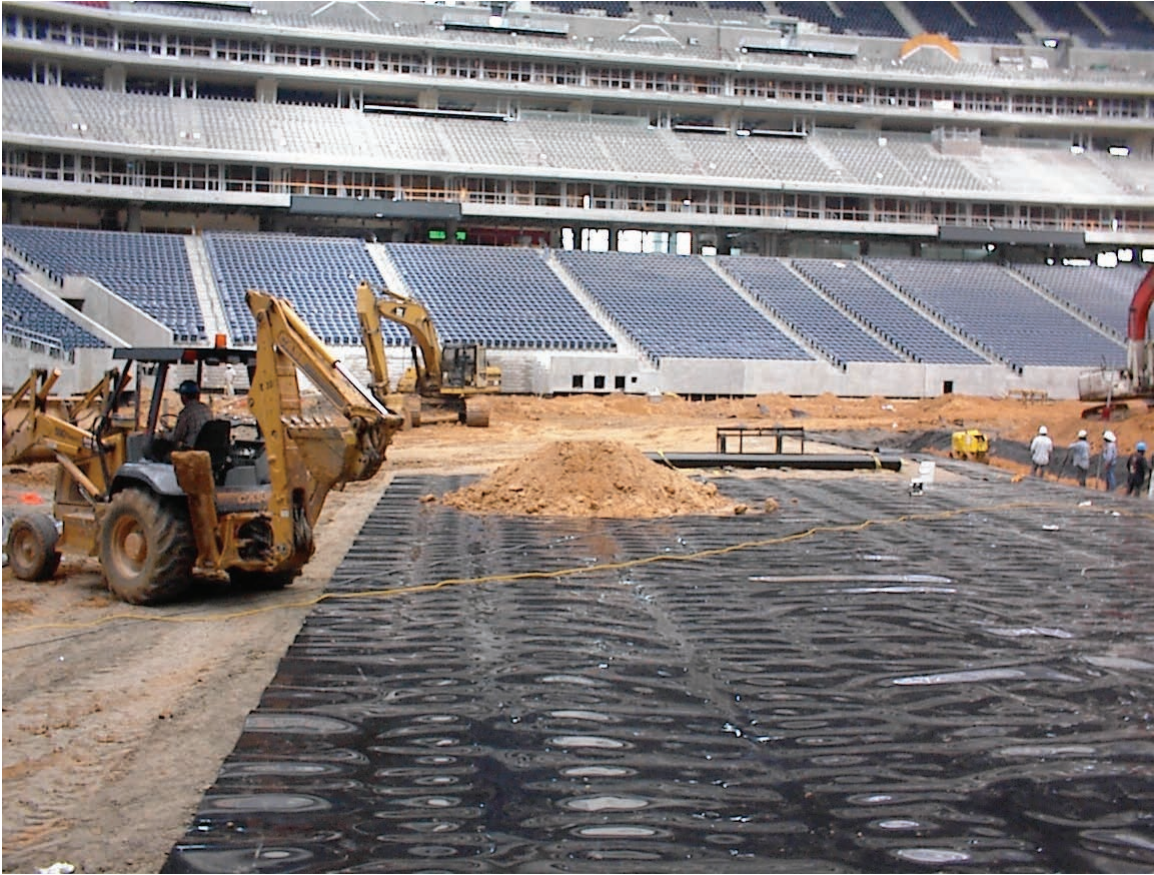
The liner's flexibility allowed for piecemeal installation. Where heavy equipment had damaged previously-laid sections, damaged pieces were cut out and new pieces were welded in place. Here, the final sections – the flat areas of the floor – are lined.

The characteristics of the liner made it possible for the project to be completed on schedule. A 60-mil thick polyethylene liner had been specified because it is affordable and durable. But its other features – flexibility and workability – allowed the installation team to piece it together, nondestructively testing welds as they proceeded. Sections laid beneath drainage pipes, for example, were put down well before the rest of the field was lined. When the time came to join old sections with new, welding them together was relatively simple. When heavy equipment damaged liner that had already been laid, the damaged piece could be cut out and a new piece welded in place. The liner was also adaptable enough to be attached to the substructures of the building using different techniques.
